## STM32F105xx and STM32F107xx revision Z connectivity line device limitations

### Silicon identification

This errata sheet applies to the revision Z of the STMicroelectronics STM32F105xx and STM32F107xx connectivity line products. This family features an ARM™ 32-bit Cortex®-M3 core, for which an errata notice is also available (see [Section 1](#) for details).

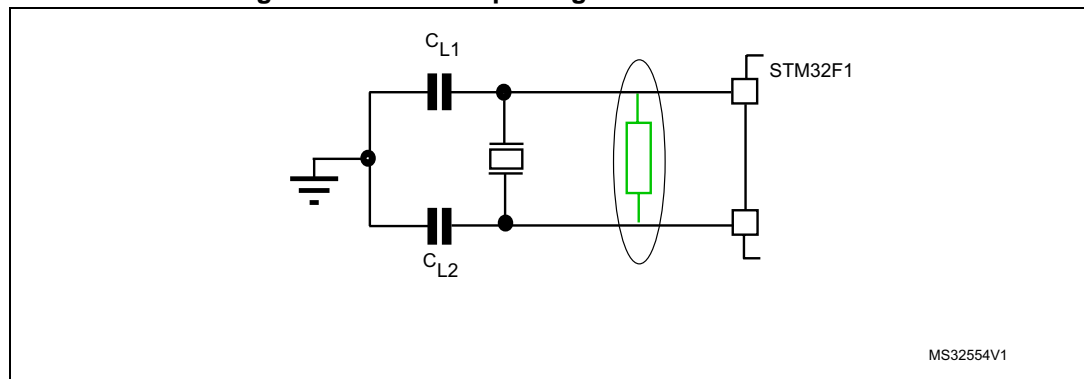
Figure 1. LSE start-up using an additional resistor

The LSE (Low Speed External) oscillator system has been designed to minimize the overall power consumption of the STM32F1 microcontroller. It is extremely important to take specific care in the design of the PCB to ensure this low power oscillator starts in harsh conditions. In some PCB designs without coating, an induced low leakage may prevent the LSE to start-up, regardless of the 32.768 KHz crystal used. This phenomenon is amplified in humid environments that create frost on the OSC32\_IN/OSC32\_OUT tracks. This unwanted behavior may happen only at the first back-up domain power-on of the device.

It is recommended to mount an additional parallel feedback resistor (from 16 M $\Omega$  to 22 M $\Omega$ ) on board to help the oscillation start-up in all cases (see [Figure 1](#)). For more details on compatible crystals and hardware techniques on PCB, refer to AN2867 application note.
